**Architectural Impact Assessment of dwellings on  
portion 9 of the farm La Mercy 15124 for Dube  
Tradeport Corporation**

**Prepared for: Dube Tradeport Corporation  
15th floor, Marine Building  
22 Gardiner Street  
Durban**

# **Architectural Impact Assessment of dwellings on portion of 9 the farm La Mercy 15124 for Dube Tradeport Corporation**

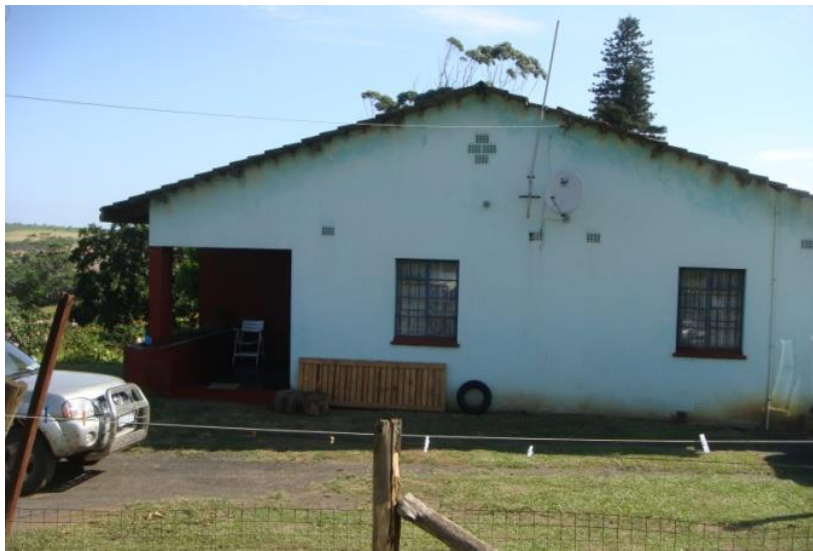
**Fig 3: Side elevation (Photo J.Mitchell 2010)**

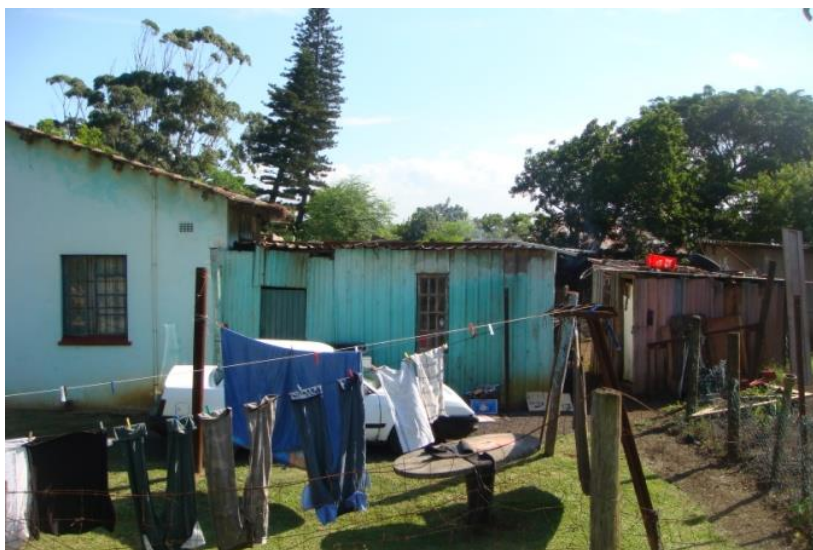
**Fig 4: Rear of building with wood-and-iron kitchen(Photo J.Mitchell 2010)**

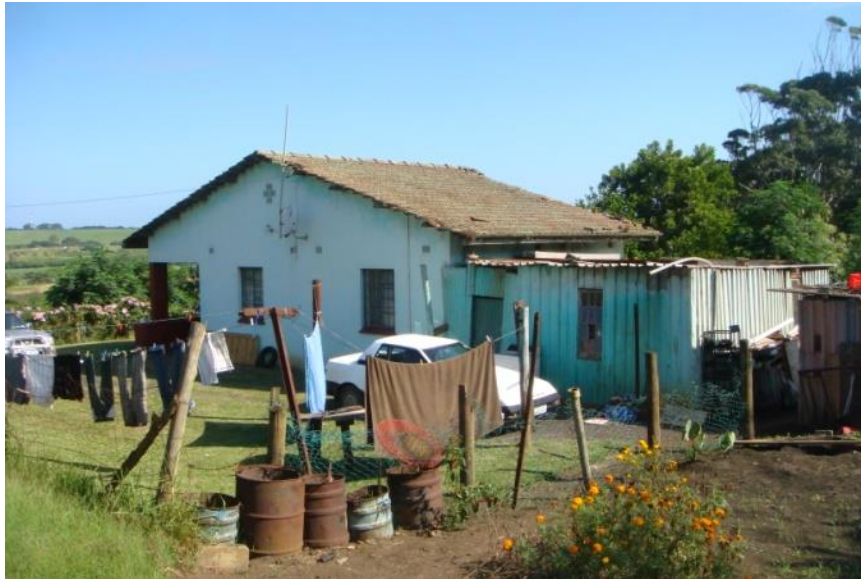
**Fig 5: Rear of building with kitchen (Photo J.Mitchell 2010)**

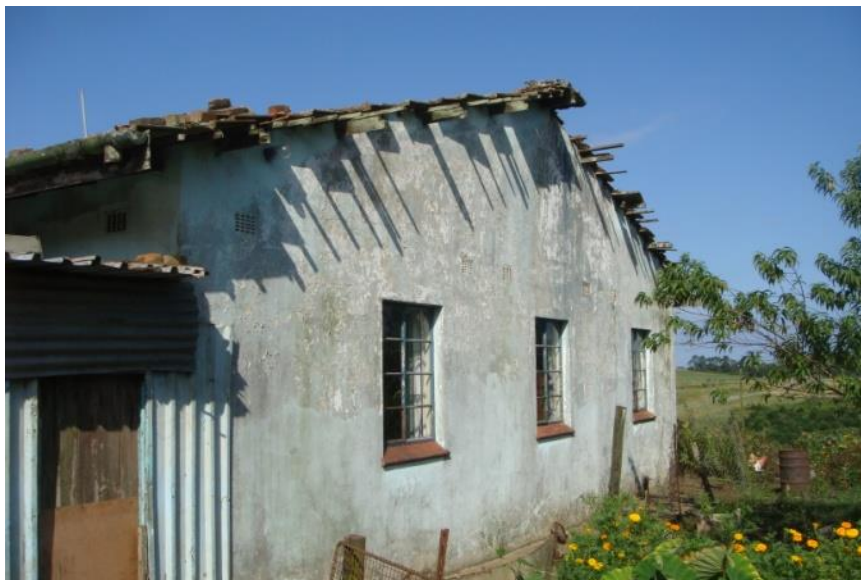
House 1 is the only one remaining. It is of conventional construction, with brick and mortar plastered and painted. The windows are steel section, and the roof is double-pitched and Marseille-tiled. It is in reasonable condition, although the roof is decaying on the south west due to lack of maintenance. It is still occupied by Ms. Reddy who intends to move out in May.

**Fig 6: Side Elevation- note dilapidated roof and attached kitchen (Photo J.Mitchell 2010)**

*Recommendations: There is little diagnostic evidence to suggest that any part of this building is over 60 years of age. However, it is strongly considered that the wood-and-iron kitchen behind it, which has been recently demolished for removal to Tongaat, dates back to the early years of the last century, with the settlement of the indentured Indians. Recent lack of maintenance and isolation make scant case for retaining this building once it is evacuated. It is recommended that demolition be allowed.*

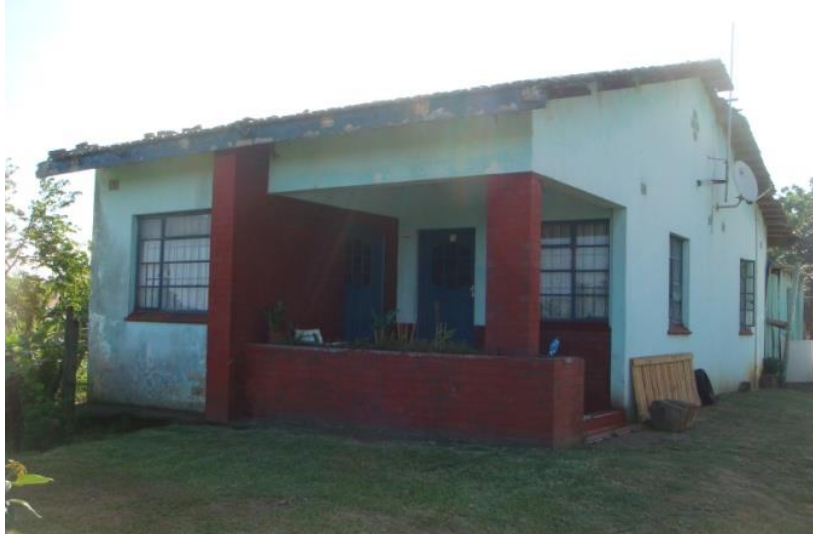
**Fig7: Front elevation: note planter box (Photo J.Mitchell 2010)**

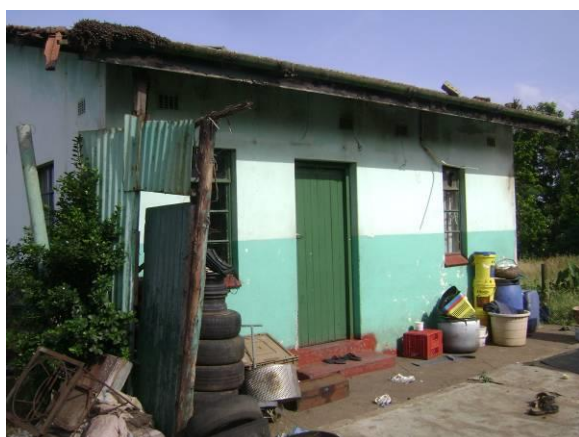
**Fig 8: Rear entrance: note slab in foreground**

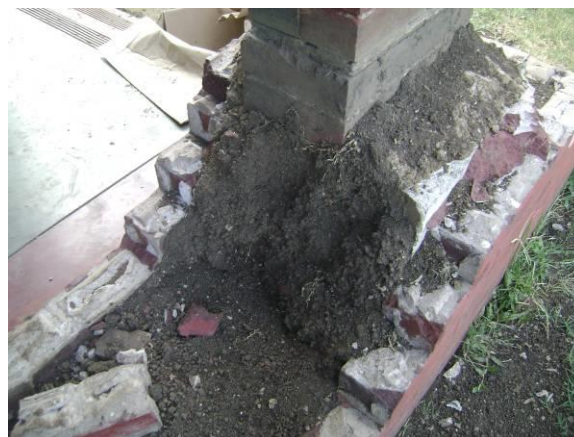
At the time of original inspection at the end of 2010, there was a two-roomed wood-and-iron kitchen block at the rear. This has since been demolished and the materials retained for removal to the new site. In addition, the front veranda had a brick and mortar planter, which has also been recently demolished.

**Fig 9: demolished flower box on veranda**

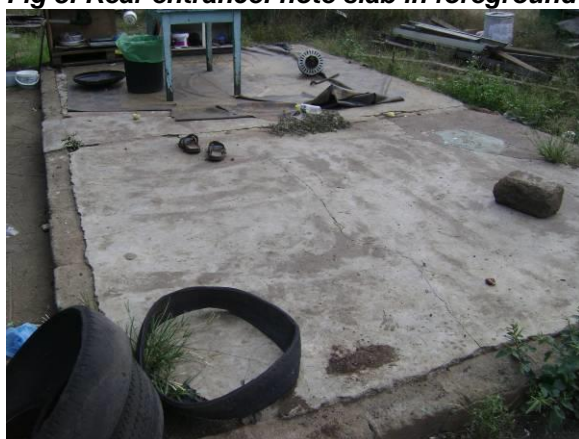
**Fig 10: Floor slab for wood and iron kitchen**

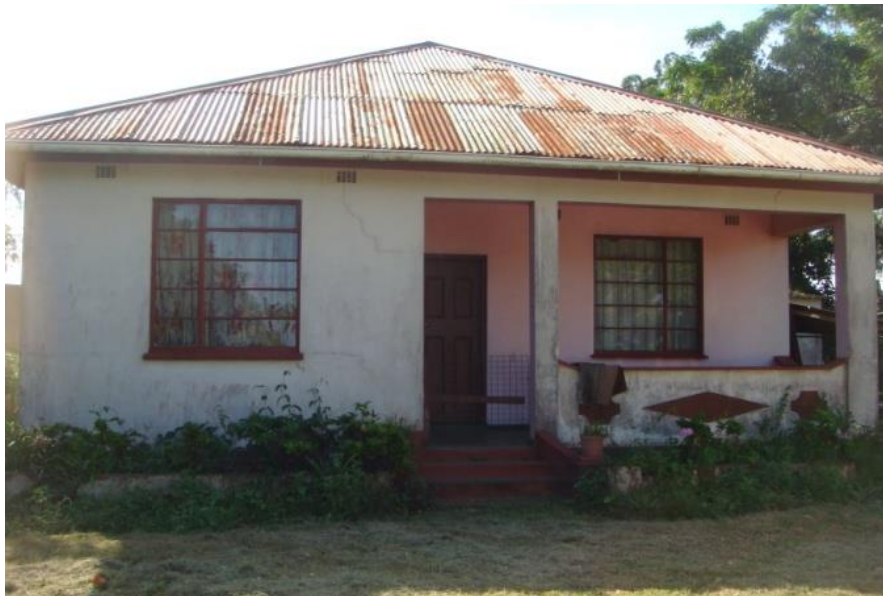
All evidence points to the bulk of this house being of conventional brick and mortar masonry construction, with a corrugated sheeting roof, which was most possibly removed by the demolishers or the previous residents. The main part of the roof was pitched with a lean-to section at the rear. The windows are standard steel section, the ones on the side elevations are in vertical format, reminiscent of earlier windows.

***Fig 12: Front of house number 2 taken in December 2010 (Photo: Jenny Mitchell)***

*Recommendations: This house may have been the single one which was constructed before 1951. Its condition appeared to have been reasonable. It is an example of a vernacular dwelling common to the Canefields area, of which many more exist. As with House 1 above, isolation would have made scant case for retaining this building once it was evacuated. Demolition, had it been sought, would have been recommended as an option.*

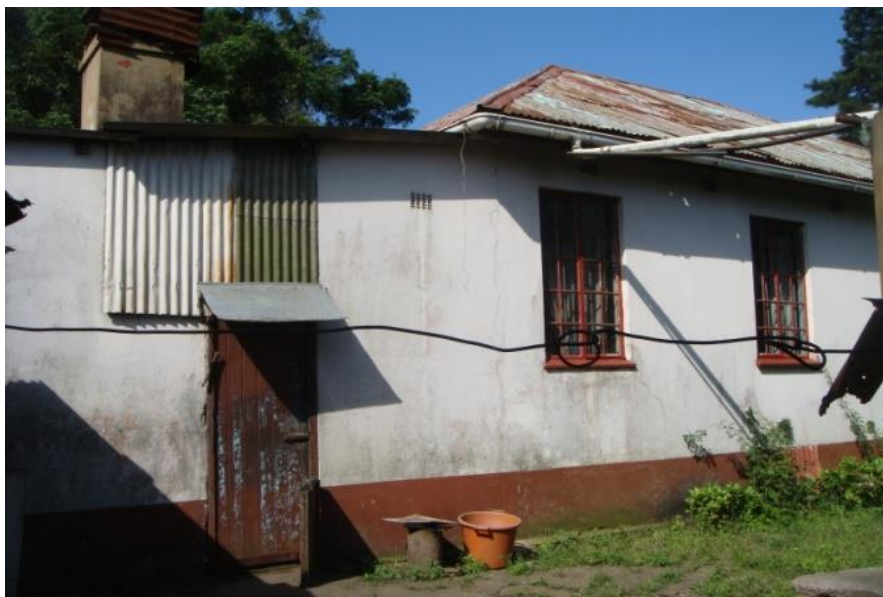
***Fig 13: Side elevation of house number 2, December 2010 (Photo: Jenny Mitchell)***

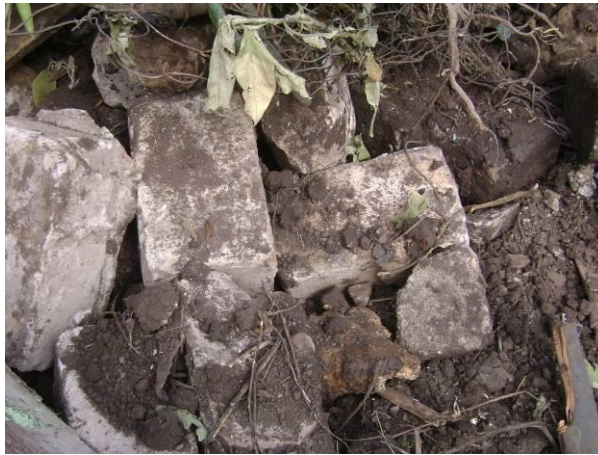
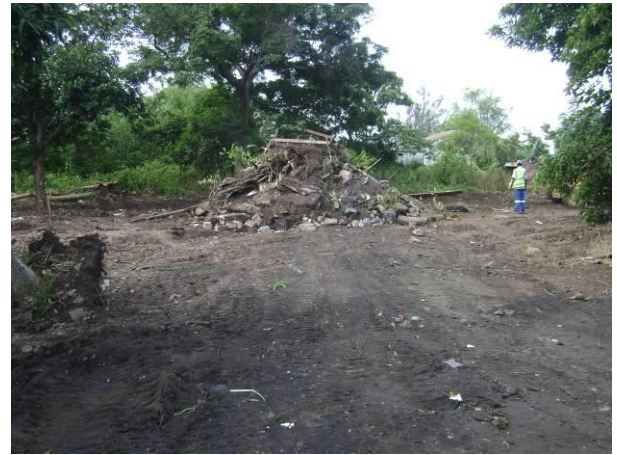
**Fig 14: Rubble heap-mixed brick and block (15/03/11) Fig 15: Rubble heap (15/03/11)**

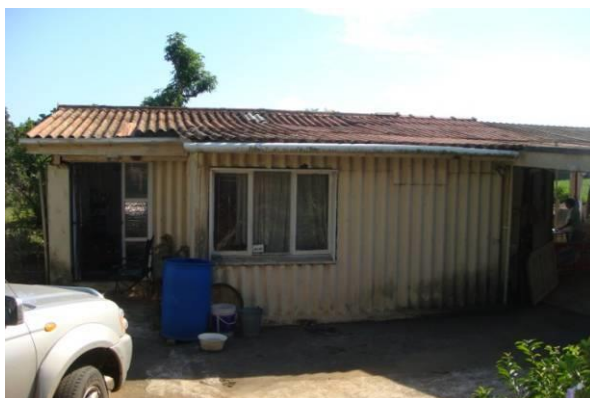
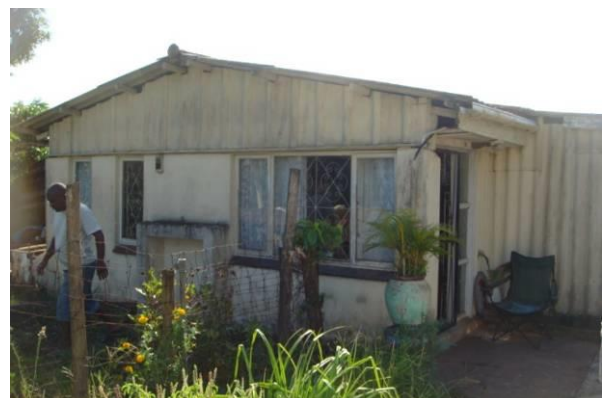
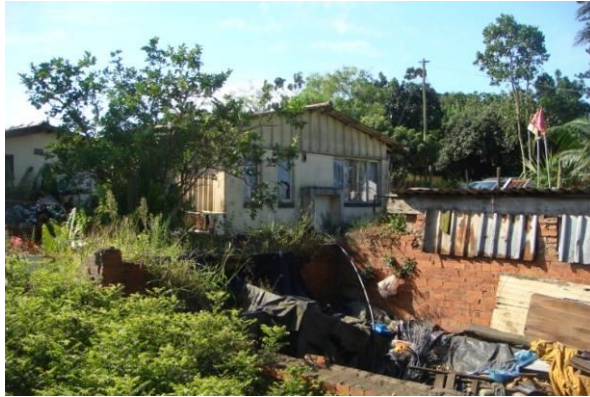
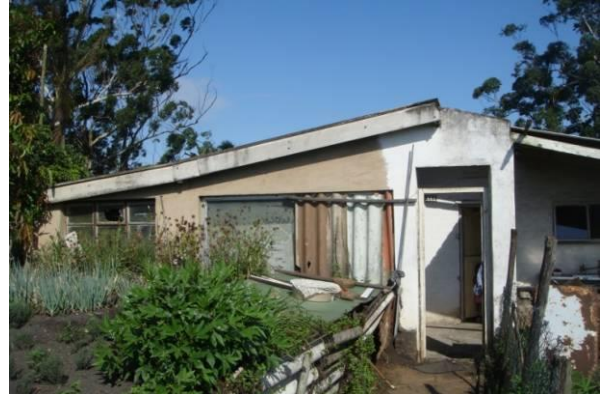
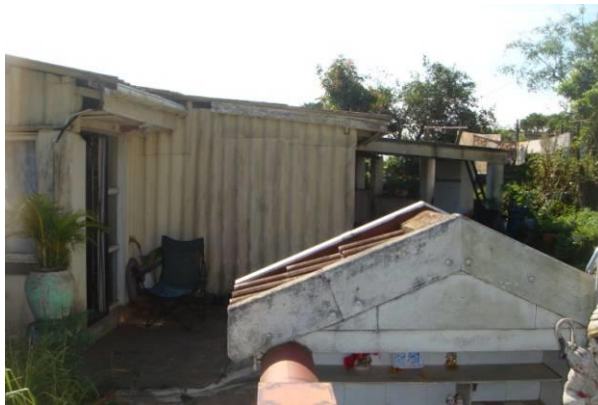
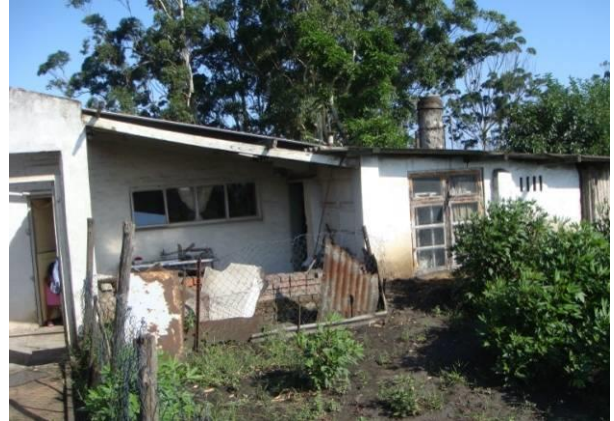
This house appears to have been of mixed and incremental construction. Parts of it consist of corrugated asbestos sheeting used for the walls and the roof, whilst others are of brick and mortar construction. There is no evidence of planning, and it has no architectural merit.

**Fig 16: House 3- Elevation (Photo: J Mitchell) Fig 17: House 3-Elevation ii (Photo: J Mitchell)**

**Fig 18: House 3- Elevation iii (Photo: J Mitchell)**

**Fig 19: House 3- Elevation iv (Photo: J Mitchell)**

**Fig 20: House 3- Elevation v (Photo: J Mitchell)**

**Fig 21: House 3- Elevation vi (Photo: J Mitchell)**

*Recommendations: This house consisted of a variety of different materials constructed at different times, including corrugated asbestos for some of the walling. It is an example of an incremental vernacular dwelling common to the Canefields area, of which many more exist. It had nothing to recommend its retention on any level. Demolition, had it been sought, would have been recommended as an option.*

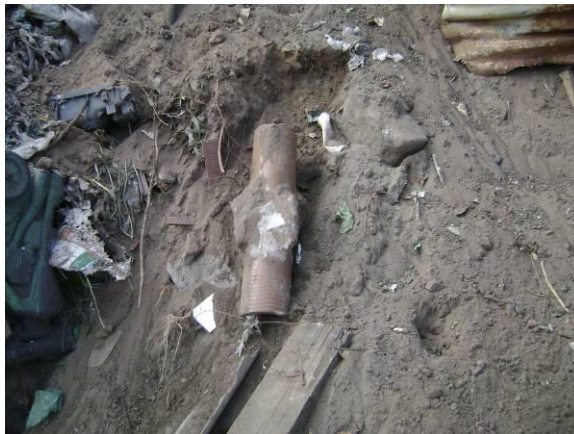
**Fig 22: Rubble: Vitrified sewer pipe**

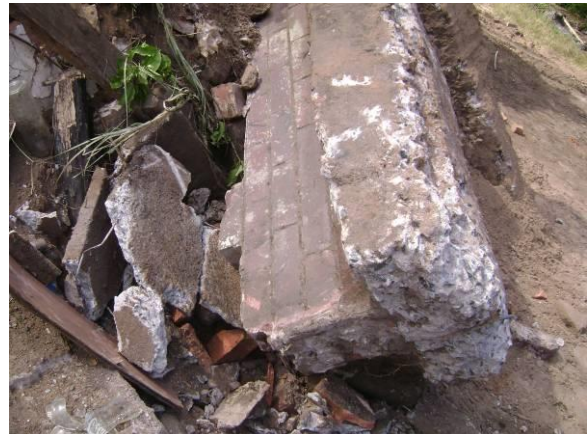
**Fig 23: Rubble- stretcher bond brickwork**

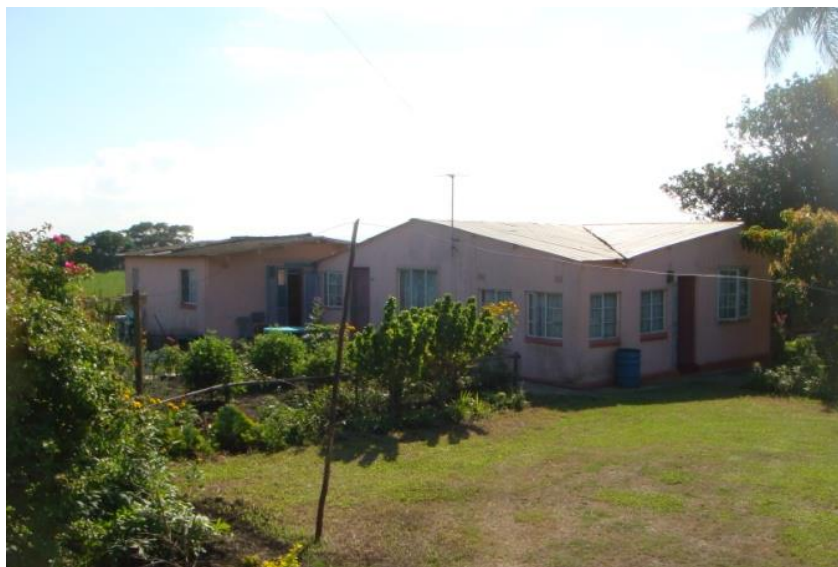
The open site was all that was left of house no 4. Pictures taken late in 2010 show a structure of sturdy brick and mortar construction, with a corrugated sheeting roof and standard steel windows. There is nothing to suggest that this building was over the age of 60 years. However, like house no 1, it had a wood-and-iron building at the rear, which probably served as the main structure until this was constructed in, most likely, the 1960s. It is a conventional house with little architectural merit.

**Fig 24: Side elevation of house number 4 taken in December 2010 (Photo: J.Mitchell)**

*Recommendations: This house was an example of a vernacular dwelling common to the Canefields area, of which many more exist. Its condition appeared to have been reasonable. As with House 1 above, isolation would have made scant case for retaining this building once it was evacuated. Demolition, had it been sought, would have been recommended as an option.*

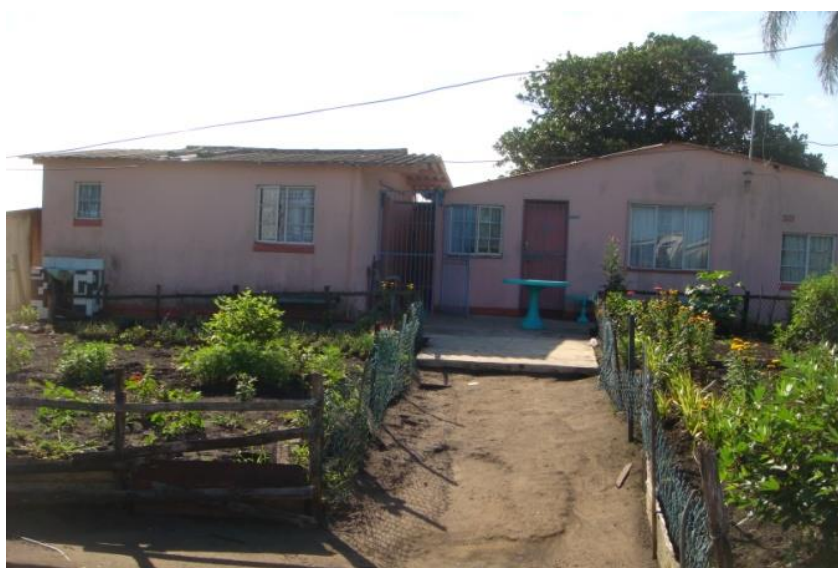
**Fig 25: Front elevation of house number 4 taken in December 2010 (Photo: J. Mitchell)**

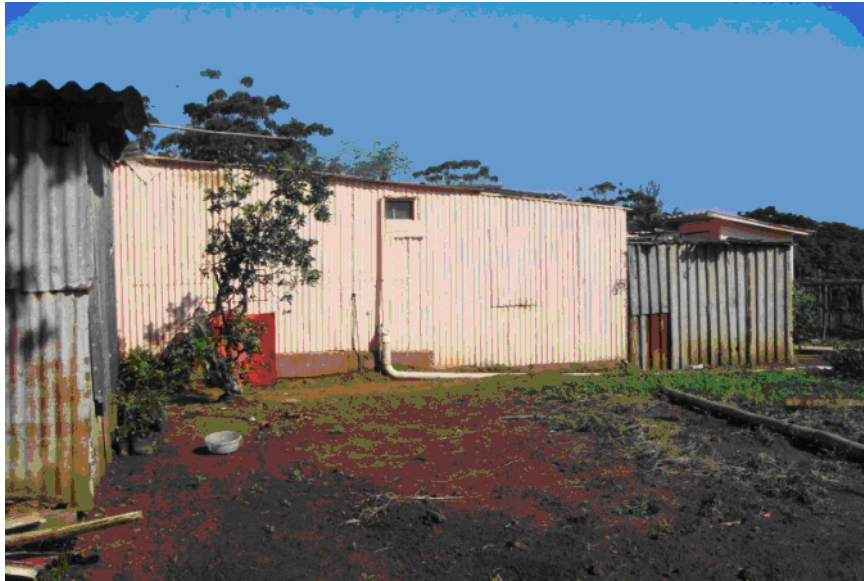
**Fig 26: Old wood-and-iron building, at house number 4 in December 2010 (Photo: J Mitchell)**

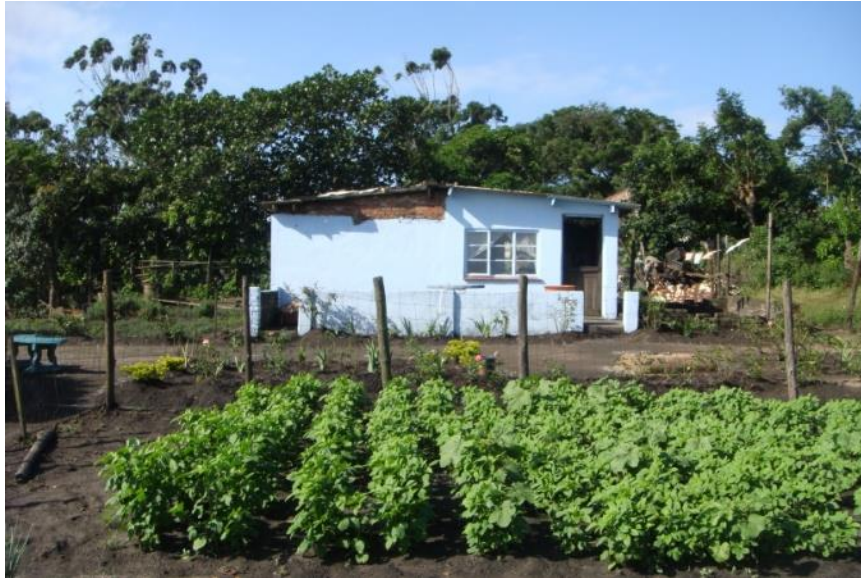
House no 5 has also been demolished. This was a modest structure of masonry construction with a corrugated iron roof and a whimsical 'stoep' wall in front. There is nothing to suggest that this building was over the age of 60 years, and no diagnostic material was found in the rubble. It had little architectural merit.

**Fig 29: House no 5, front elevation in December 2010 (Photo: J Mitchell)**

*Recommendations: This house was an example of a vernacular dwelling common to the Canefields area, of which many more exist. Its condition appeared to have been reasonable. As with House 1 above, isolation would have made scant case for retaining this building once it was evacuated. Demolition, had it been sought, would have been recommended as an option.*

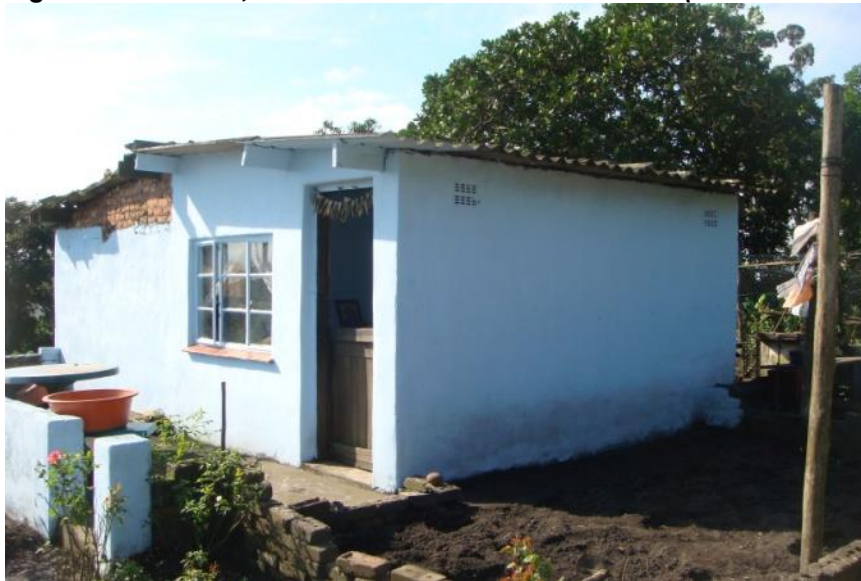
**Fig 30: House no 5, front door and 'stoep' wall in December 2010 (Photo: J Mitchell)**

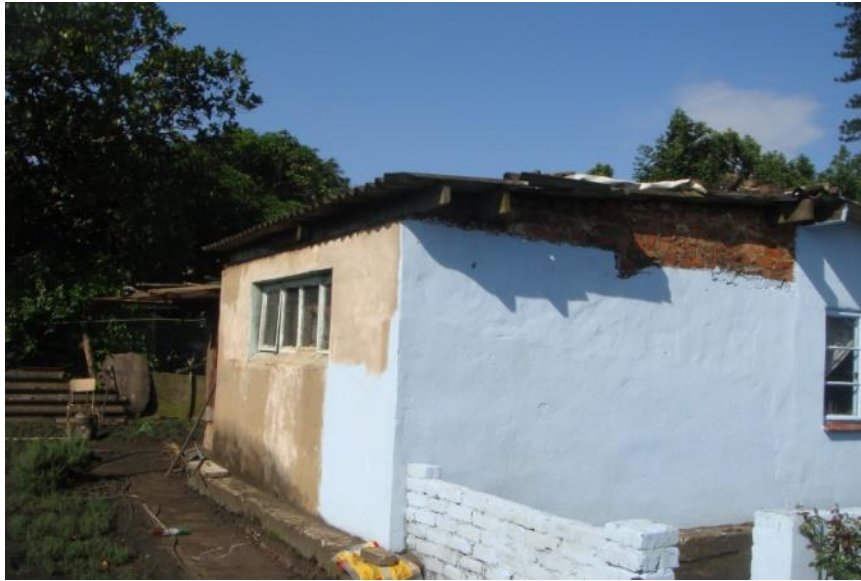
**Fig 31: Side elevation in December 2010 (Photo: J Mitchell)**

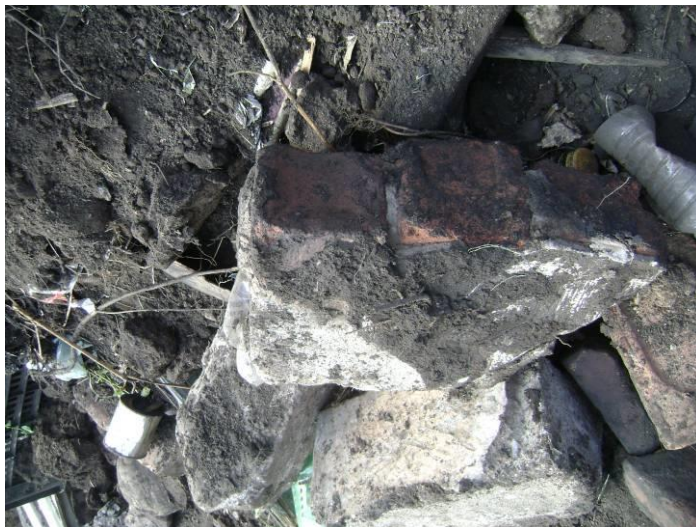
**Fig 32: Rubble heap**
